# Manhole Inspection Summary

Manhole # S21Y\_\_014MH

Insp Date: **11/25/08 9:15 AM**

**Location** Address: **2106 Maisel St.**

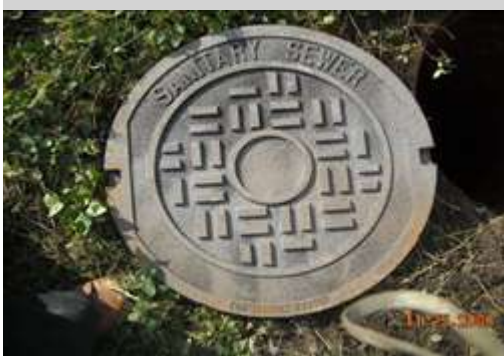
Misc

Replaced with water tight lid

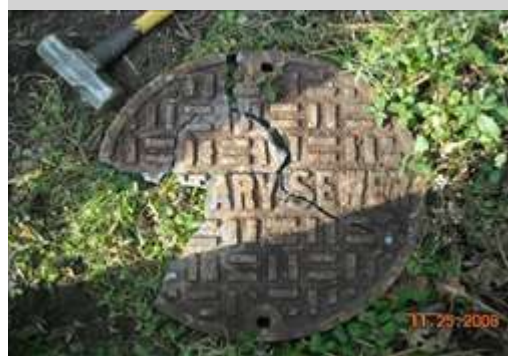
Misc

Broke lid to gain access

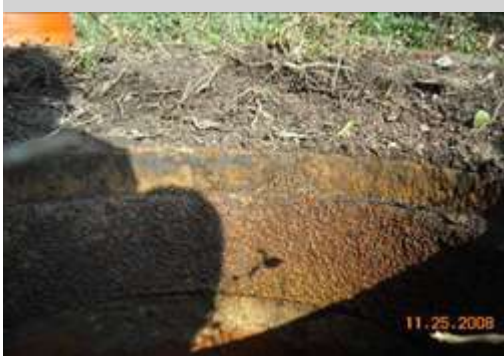
Defect 1

Comments **Located with the use of a metal detector. Manhole was located 4 inches underground, in which it had to be dug up. Also manhole is in an abandoned lot at address above. Manhole lid was an break and replaced with water tight lid. Manhole frame to be raised**

Frame below grade

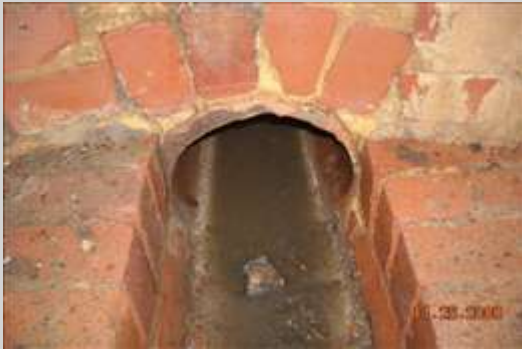
12 O'Clock Outflow

8 in. Circular Gravity Sewer  
Pipe Out @ 12 O'Clock

Pipe Height: **8.4** (in.) Rod and Bar (Angled)  
Pipe Material: **Clay** ☐ Pipe Lined  
Invert Depth: **10.40** (ft.) Flow Characteristics: **Slow**  
Deposits: ☒ None ☐ Mud ☐ Sludge ☐ Debris ☐ Grease  
Silt Depth: **0** (in.) Deposits Extent:  
Infiltration: **None** Pipe Seal Cond: **Sound**

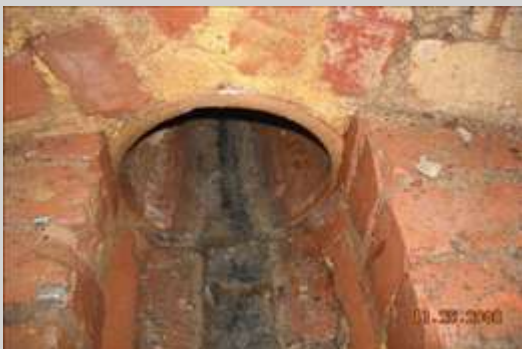
6 O'Clock Inflow

8 in. Circular Gravity Sewer  
Pipe In @ 6 O'Clock

Pipe Height: **8.4** (in.) Rod and Bar (Angled)  
Pipe Material: **Clay** ☐ Pipe Lined  
Invert Depth: **10.23** (ft.) Flow Characteristics: **Slow**  
Deposits: ☒ None ☐ Mud ☐ Sludge ☐ Debris ☐ Grease  
Silt Depth: **0** (in.) Deposits Extent:  
Infiltration: **None** Pipe Seal Cond: **Sound**
